CTB-00423 Rev 002

Product: Selenia

Subject: Image Artifacts Due to Detector Impacts or Improper C-Arm Motion

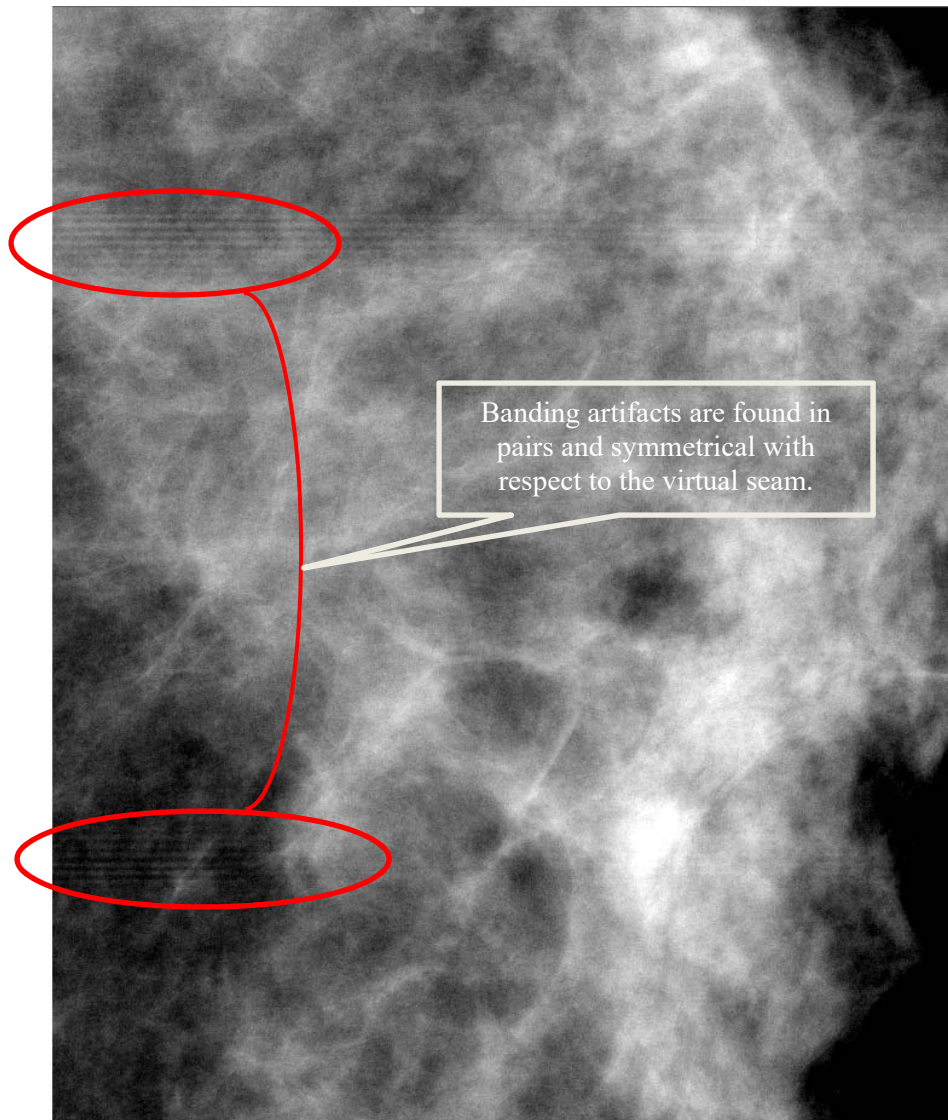
To better understand this issue it is important to review the operation of the image presentation mechanism of the Selenia system. When an image is acquired it is first presented on the Acquisition Workstation (AWS) as a low resolution image in order that the room technician can quickly see that an appropriate image was acquired. As this image is being displayed the remainder of the image data is still being transferred from the detector to the AWS. The detector circuitry is very sensitive to external vibration during the entire data transfer. The full resolution data transfer from the detector to the AWS can take as long as 15 seconds. Any impact or unexpected mechanical movement may introduce “noise” into the image resulting in image artifacts.

Example of Gate Banding

To avoid the possibility of external introduced image artifacts the following steps should be observed:

- Make sure the patient or technician does not strike the detector during the 15 second data transfer time. This can easily happen with loose fitting jewelry or clothing.

- Be sure not to rotate the C-Arm during the 15 second data transfer time.
